UAV STRATEGIES VALIDATION AND REMOTE SENSING DATA FOR DAMAGE ASSESSMENT IN POST-DISASTER SCENARIOS

A. Calantropio¹, F. Chiabrando¹, G. Sammartano¹, A. Spanò¹, L. Teppati Losè¹

KEY WORDS: UAV photogrammetry, Rapid Mapping, Remote Sensing, Seismic emergency, 3D models, Damage assessment

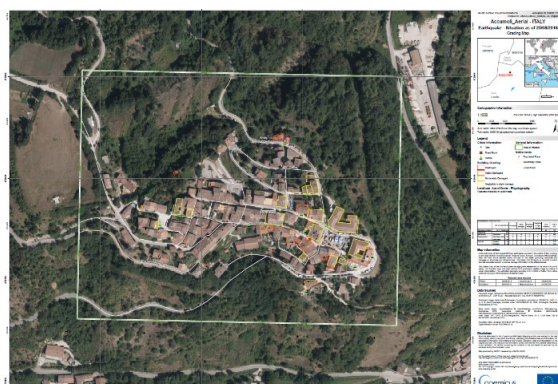
Figure 1. Post-event Grading Map for Accumoli (RI), Italy.

Aerial image from © European Commission (acquired on 25/08/2016, GSD 0.1m, 0% cloud coverage) provided under COPERNICUS by CGR, *Compagnia Generale Riprese aeree*.

Once the service is activated, three different products as is reported in (Boccardo, 2013) could be obtained: *reference maps*, *delineation maps* and *grading maps* (Figure 1 provide an assessment of the damage grade and of its evolution if requested. In this specific paper the focus will be oriented to the produced grading maps in the area of central Italy that are available, according to the EMS rapid mapping procedure, in a time range between 3 and 12h.

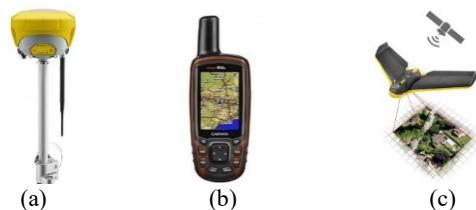
Figure 4. Tested strategies for georeferencing the UAV photogrammetric blocks. (a) GNSS RTK Geomax Zenith35 receiver, ~10.000€; (b) Garmin GPSMAP® 64s handheld receiver, ~300€; (c) exterior orientation associated to the UAV images by *GeoTag*.

The use of consumer grade GPS/GNSS handheld receiver, Figure 4(b), has proved to be faster than the traditional RTK procedure, involving undoubtedly cheaper and easy-to-use instruments; however, this won't firstly overcome the related safety issues, as the operator will have to traverse dangerous areas anyway. The comparison of residual errors on check points (CPs), in Table 4, has been performed on the cartographic product, separately computed by use of GCPs measured by the two GNSS receivers, the geodetic RTK and the handheld receiver. The results demonstrated the expected problem of accuracy, in meters magnitude, affecting those types of receivers.

The use of the positioning information embedded in the acquired UAV images as exterior orientation, Figure 4(c), can be another valuable solution in case of impossibility to directly measure GCPs on the ground. The UAV device used in this case is the eBee™ Basic version, equipped with consumer GPS on board receiver; neither the RTK version nor the recent PPK version have been tested. It can provide, by the so-called *geotag*, the exterior orientation, i.e. the direct georeferencing of image shooting position. The comparison of the parallel use of geodetic GNSS receiver and images *geotag* is performed and validated, as reported in Table 5, and show more limited errors results in comparison with those ones from Table 4.
